Coatings Consultants Inc.

IT PAYS TO BE PREPARED

By Bob Cusumano

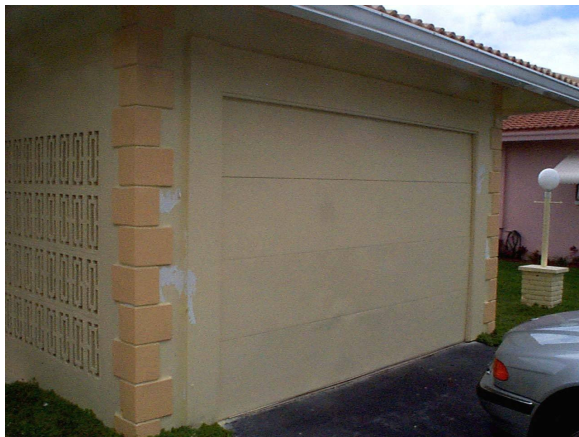
In repaint situations, you must determine the soundness of the existing paint coats. As exterior paints weather, a surface chalk often usually develops which can interfere with paint adhesion, especially when the paint that you are applying is a latex. If that surface chalk is heavy, it must be removed. If it is light, then a masonry conditioner whose function is to bind the light chalk to establish a sound surface can be used. Photo 1 shows one of four hundred and fifty houses that was in the process of being painted. About halfway through the project some peeling began to occur. When he pressured cleaned the house the second time, look at all of his paint that was removed (photo 2). The problem was that there was a very thick layer of the chalk that was not removed during surface preparation. Even though a masonry conditioner was applied it could not penetrate through the six mils of chalk on the surface. Unfortunately, this painting contractor went out of business due to this project.

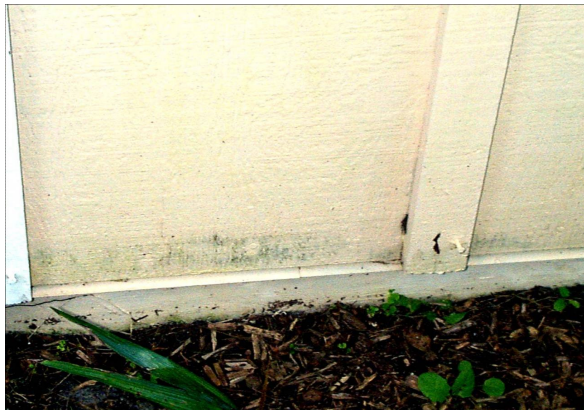
Dirt, mildew, wax, oil, salt, are other surface contaminants that may interfere with the establishment of good coating adhesion and must be removed using appropriate measures. Photo 3 shows a residence with wood siding where the contractor painted over mildew. When this occurs, the mildew continues to grow beneath the paint. The remedy is to strip the paint, kill the mildew, and repaint. It's always cheaper to do it right the first time. Photo 4 shows the result of painting over a door that had been waxed.

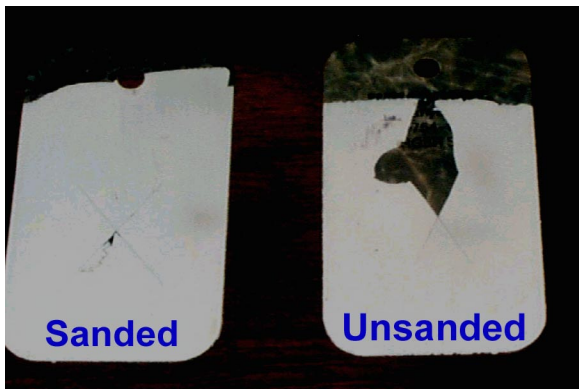
Hard, smooth surfaces should be sanded and wiped clean to de-gloss the surface and promote good mechanical adhesion. Photo 5 shows that this is an effective procedure. The shiny plastic laminate coupon on the left was sanded and wiped prior to painting. The coupon on the right was left in its natural state. Adhesions tests on each sample show that sanding and wiping increases the adhesion.

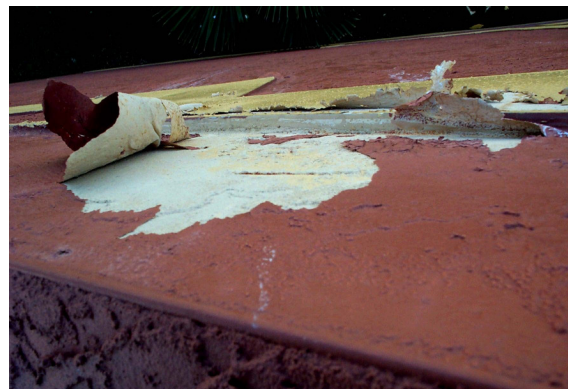
Photo 6

But in repaint situations, not only does the surface being painted need to be evaluated but also the adhesion of the existing coatings. It is common that when additional coats are applied to a previously painted surface that has marginal paint adhesion, the additional weight and stress produced may cause delamination, especially when applying top of the line products. Therefore, it's important to test the adhesion of existing coats to avoid failures like those shown in photo 6.

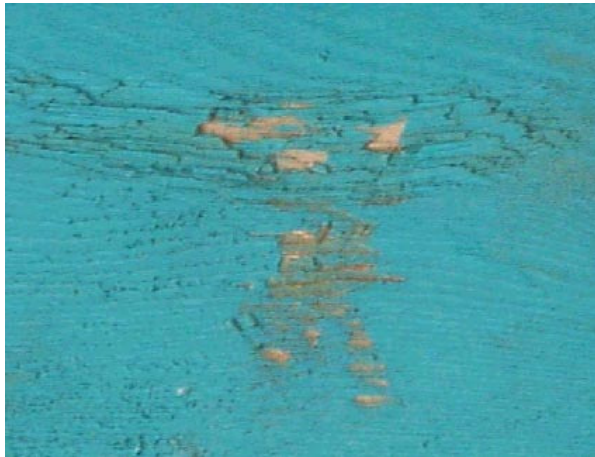
Photo 7

Now let's address some adhesion issues when painting new exterior surfaces. Rough sawn wood, especially when weathered, has loosely attached wood fibers on the surface. If a latex paint or solid stain is spray applied to this surface, then poor adhesion often results due to the paint laying on the surface and loose fibers detaching from the wood carrying the paint with it. This condition is shown in the adhesion test result in photo 7. When that same wood was painted by brush instead of sprayed (photo 8) the adhesion was improved because the paint was "worked into" the substrate.

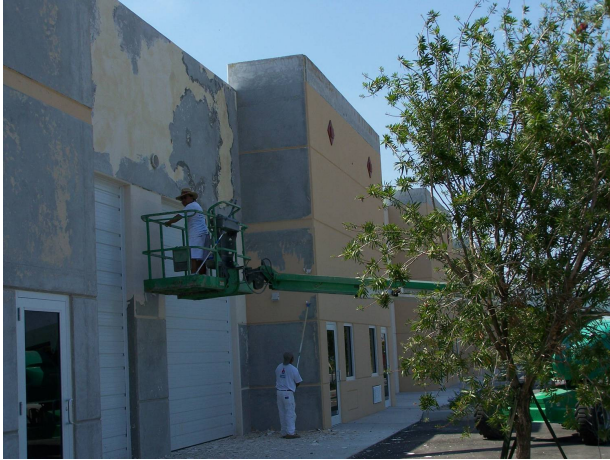
Photo 9

There are a few issues to be concerned about when painting new concrete. The surface of new concrete is often very hard and slick. The warehouse shown in photo 9 had to be stripped, acid etched, and repainted because good mechanical paint adhesion was not established.

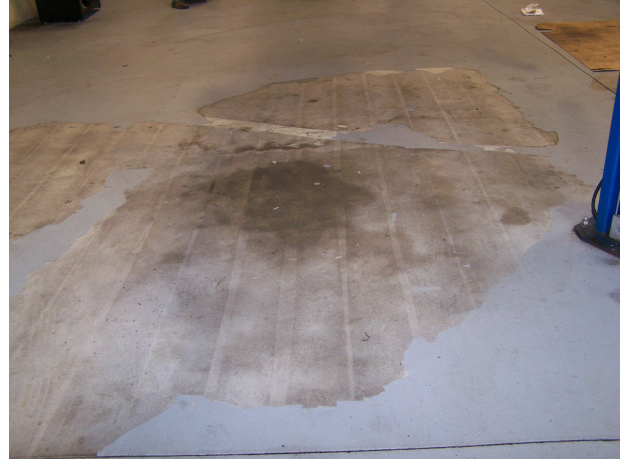
Laitance is a thin layer on the surface of new concrete that consists of fine particles due to the upward migration of water during the placement and curing process and often occurs on concrete floors. This concrete layer is of low strength and should be removed when surface preparation is performed, preferably by shot blasting. Photo 10 shows what can happen when a concrete floor is not properly prepared.
