Nassau Hall – Restoring a 95 Year Old Mansion in Muttontown, NY

Delano & Aldrich, the prominent architect of the '20s made his first commission in this area. His first commission is the Christie House on Muttontown Rd whose exterior wall was modeled after Mount Vernon, the home of our first president, George Washington. This mansion is now called Nassau Hall owned by Nassau County. Nassau Hall was built by Delano & Aldrich for the Winthrop family and was known originally as the Egerton L. Winthrop Jr. House or Muttontown Meadows. The estate was purchased by Lansdell Christie in 1950 and hence called the Christie House. His widow, Helen Christie sold the house and its 183 acres to Nassau County in 1969. It is now the home of Nassau Parks Conservancy. The grounds at Nassau Hall have one of the biggest collections of pine trees in all of Long Island, NY.

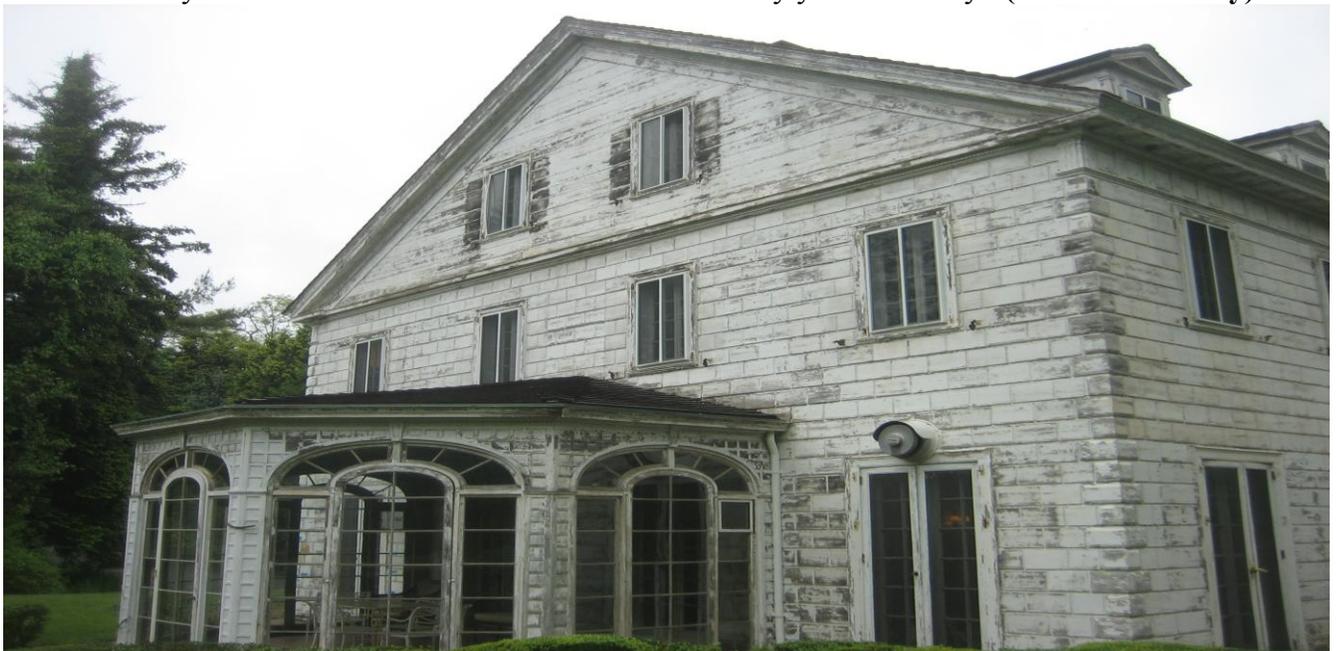
Nassau County wanted to rehabilitate Nassau Hall after many years of decay. **(Picture #1 Decay)**

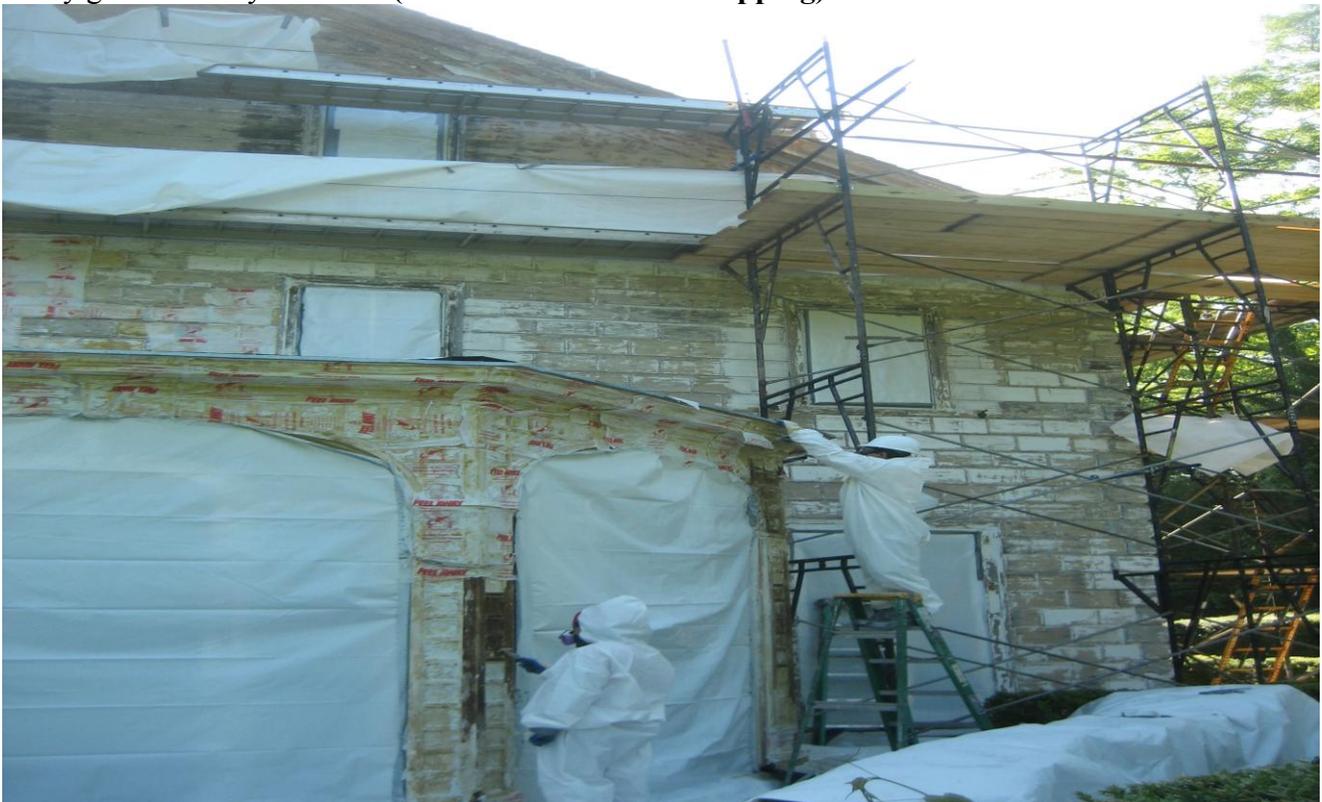
Our scaffolding team began to construct and contain the work area to allow the removal of the lead paint. Because of the hazardous materials present Alpine had to take great caution while performing the abatement work. Pre and post soil samples were taken to ensure that the work did not further contaminate the surrounding soil. Decontamination areas were set up including signage and hand wash stations. Protective clothing was utilized to protect our workers including respirators, rubber gloves, safety glasses and tyvek suits. **(Picture #2 Chemical Stripping)**

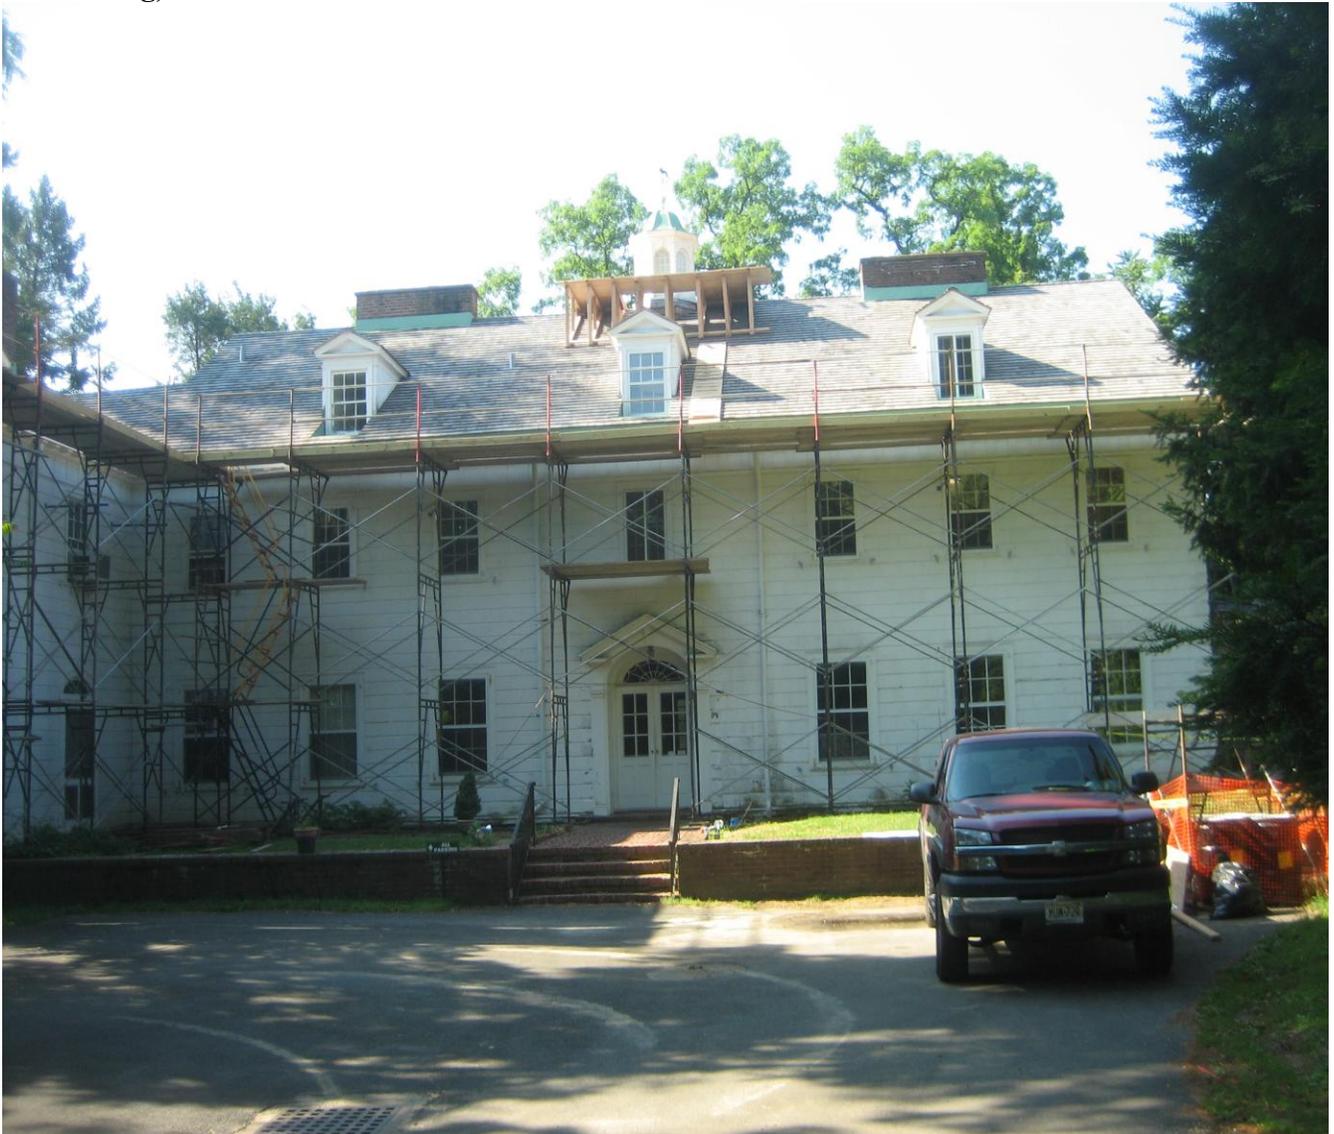
The scaffolding was 320 linear feet around the building and 22 feet high. **(Picture #3 Scaffolding)**

It was installed with the required safety railing system and numerous posted signs. The scaffolding was inspected daily by site supervisors to ensure it was safe to work on. Additionally, after the scaffolding was erected the scaffold planks had to be individually secured with wire to the frames due to an impending hurricane (Hurricane Earl) that was forecasted to hit the area. Fortunately, the hurricane moved further out to sea and was primarily a rain event.

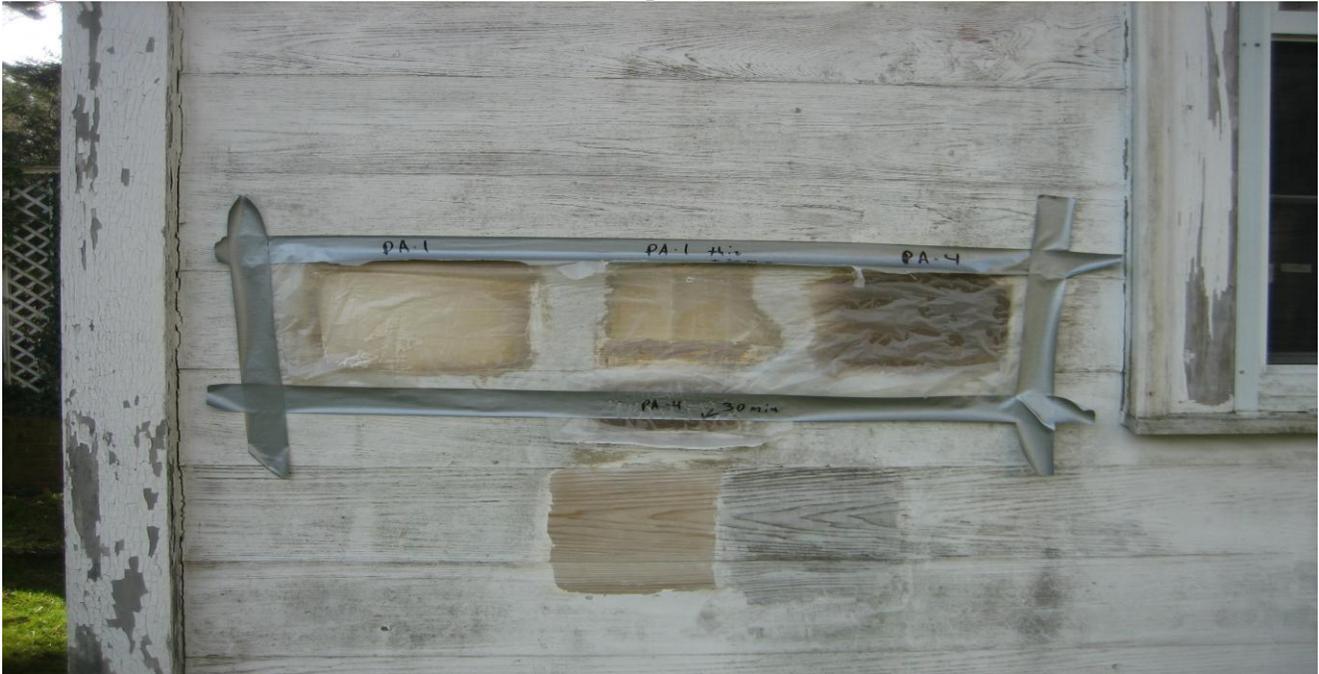
Once the scaffolding and containment were completed our crew began the process of safely removing the 100+ years of accumulated paint on the building. Several chemical strippers were applied to find

the product that worked the best. **(Picture #4 Samples)**

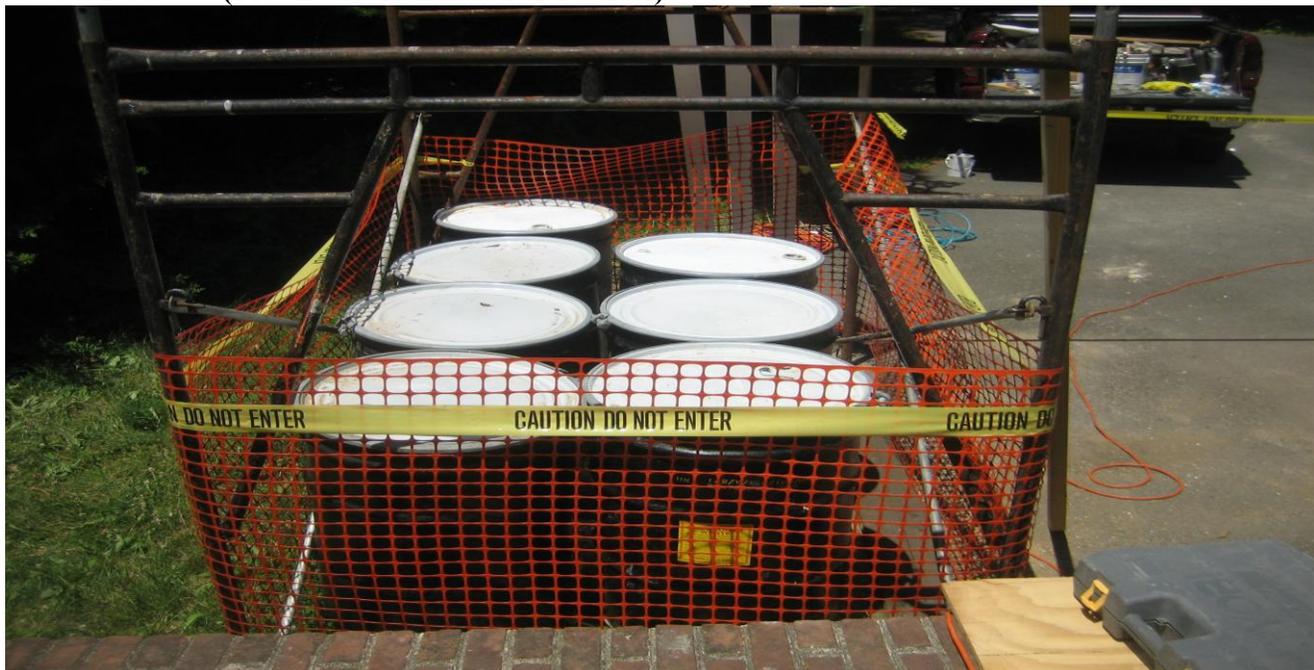
It took over 500 gallons of Peel Away 1 on over 11,000 square foot building to remove all of the old layers of paint. The product was sprayed on and removed by hand. All hazardous material generated from the preparation phase of this project, was removed from the site in accordance with all local, state and federal laws. **(Picture #5 Hazardous Material)**

The paint removal process was lengthy. It took us well into the summer of 2010 which caused the chemical stripper to dry much quicker than expected. Working in the extreme heat also took a toll on the workers. Numerous days had to be cut short due to the hot conditions. In some cases the peel away had to be applied and removed up to 5 applications to ensure that all of the lead based paint was abated from the structure.

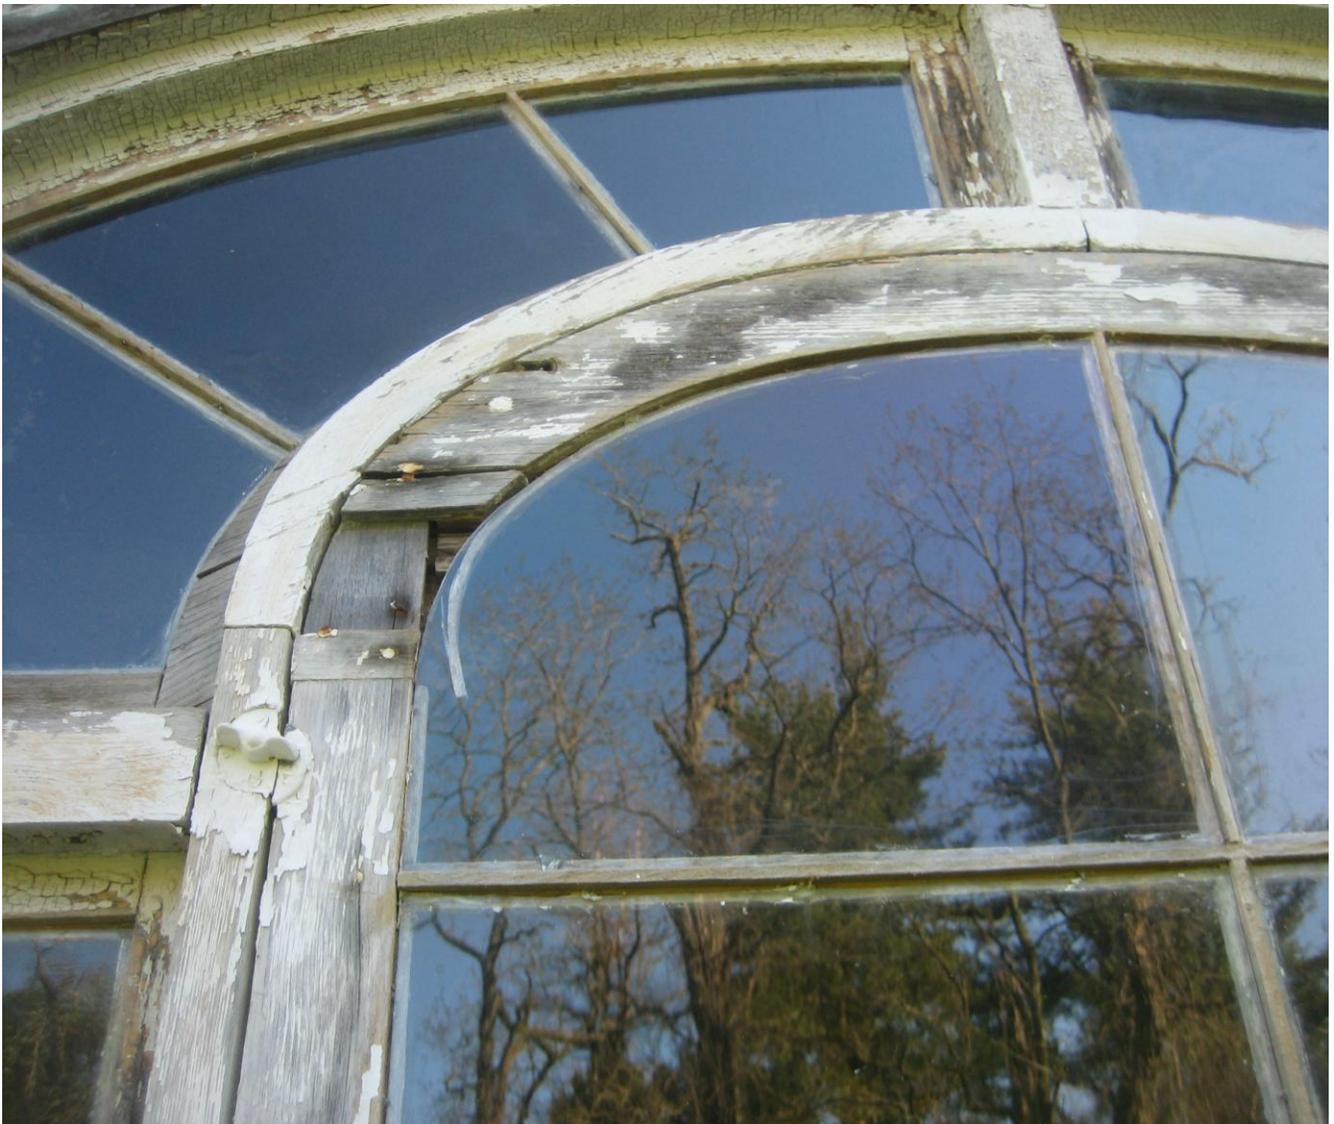
While the paint removal was occurring, other trades were simultaneously working on the project. The existing window glazing contained asbestos, another hazardous material. Glazers were brought in to remove all the old glazing from the windows and doors, as well as repair any broken windows. **(Picture #6 Glazing Replacement)** This waste was also hazardous and had to be removed following the proper guidelines as required by a licensed contractor.

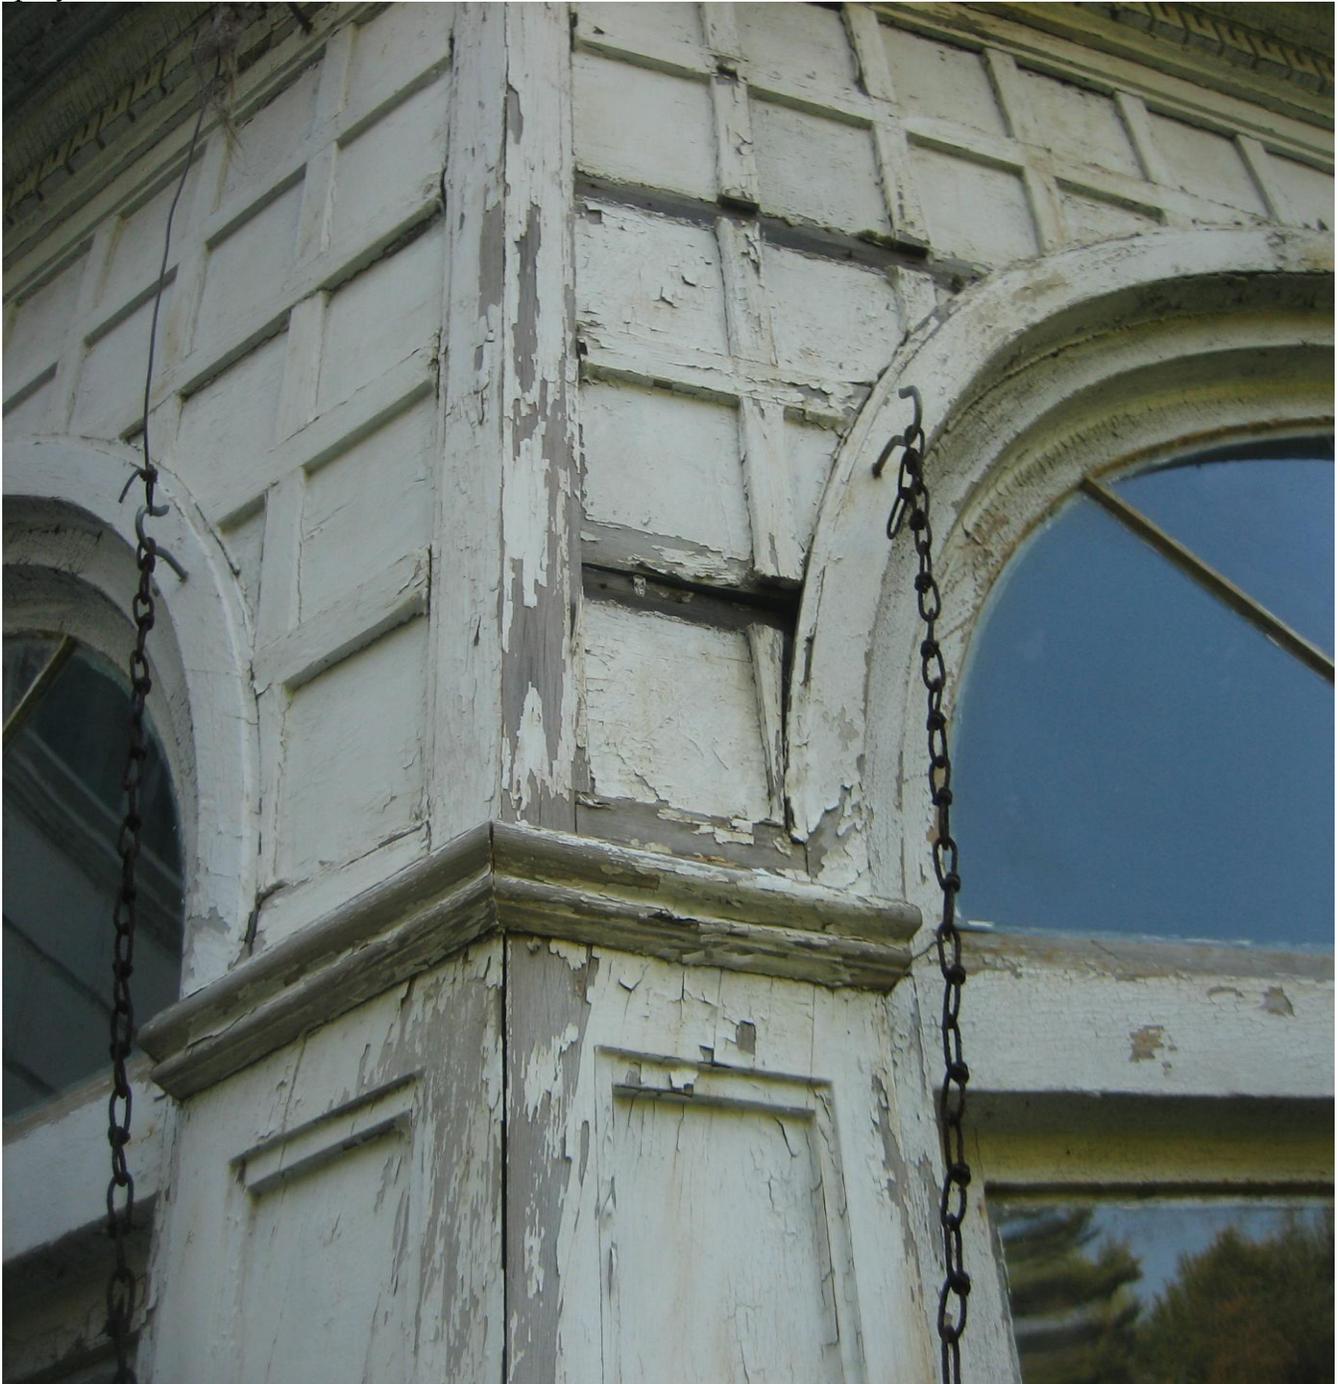
Along with the above craftsmen, Alpine's carpenters were repairing numerous rot and damaged wood surfaces. **(Picture #7 Wood Repairs)** This proved to be more difficult than anticipated as hornets had made nests on the buildings exterior. Our carpenters had to work with a hammer in one hand and insect spray in the other.

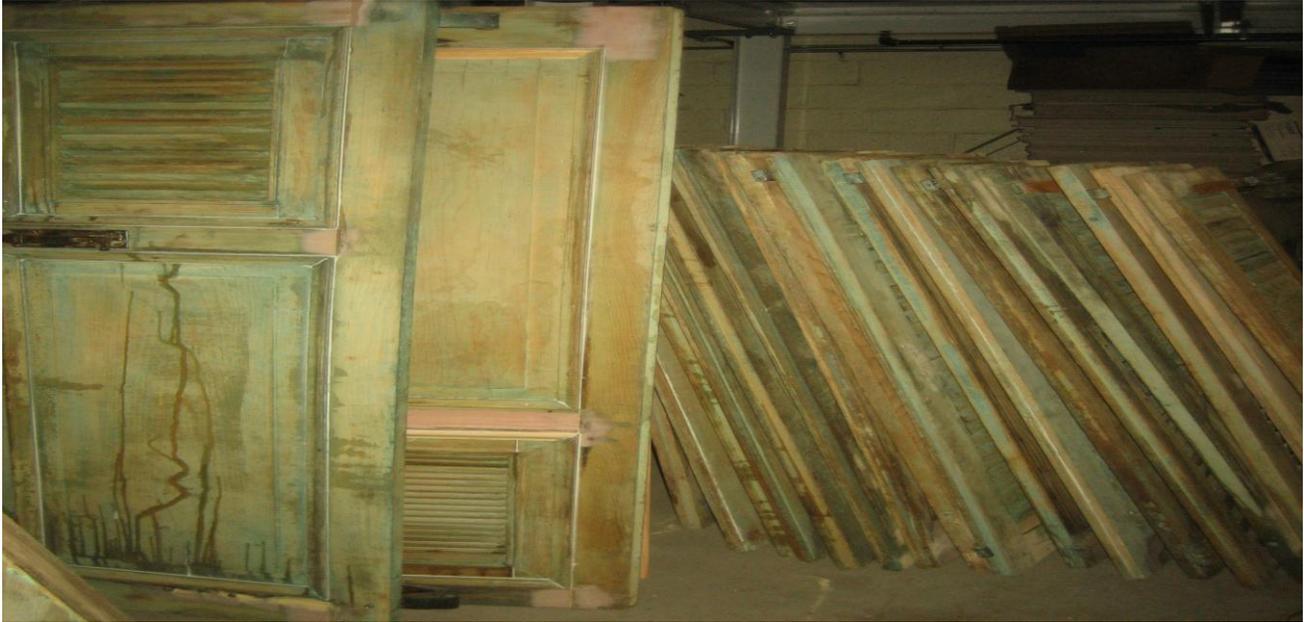
There were close to 100 existing shutters on Nassau Hall that were stripped to bare wood. **(Picture #8 Stripped Shutters)**

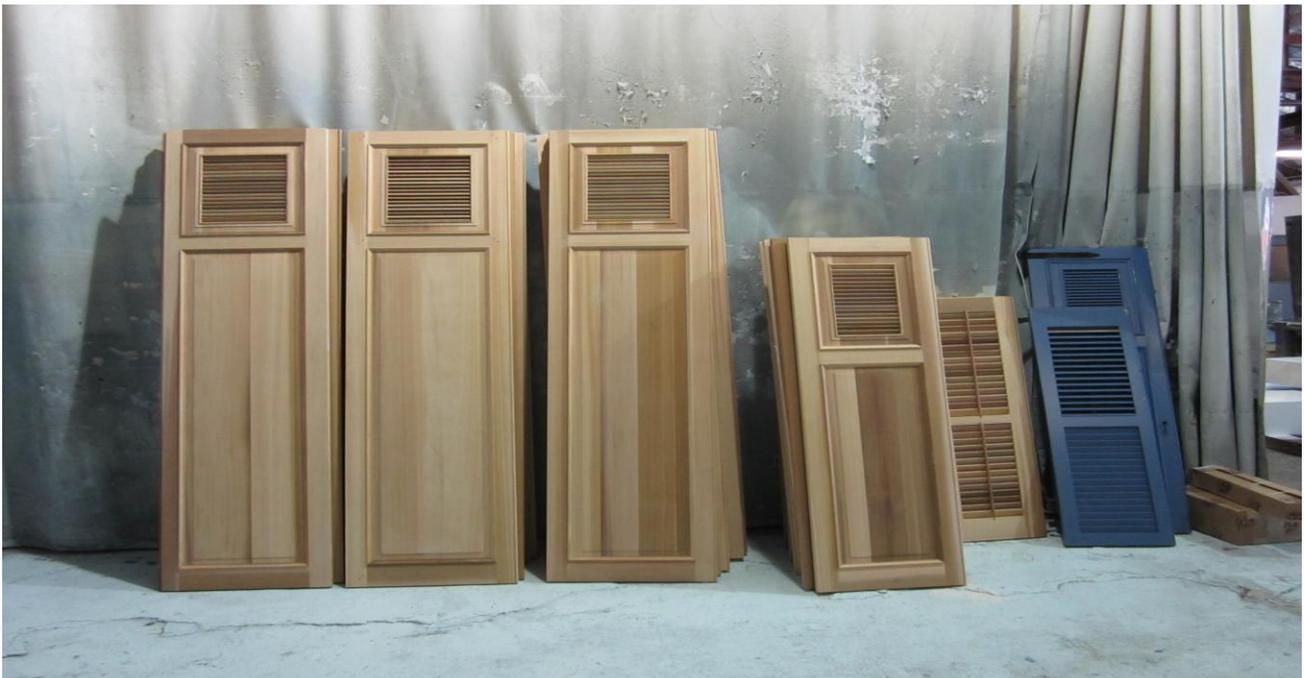
Most had damage but many were beyond repair. We contracted Timberlane Shutters of Pa. to make replicas of the shutters and the associated hardware. **(Picture #9 New Shutters)** This was so that the entire building would have matched shutters and hardware everywhere on the building.

The trim and doors were brushed applied using Sherwin Williams A-100 Latex Semi Gloss. The final step was to paint the existing and new shutters using Sherwin Williams A-100 Latex Semi-Gloss Finish, in a Denim color and then reinstall them back in their exact positions.

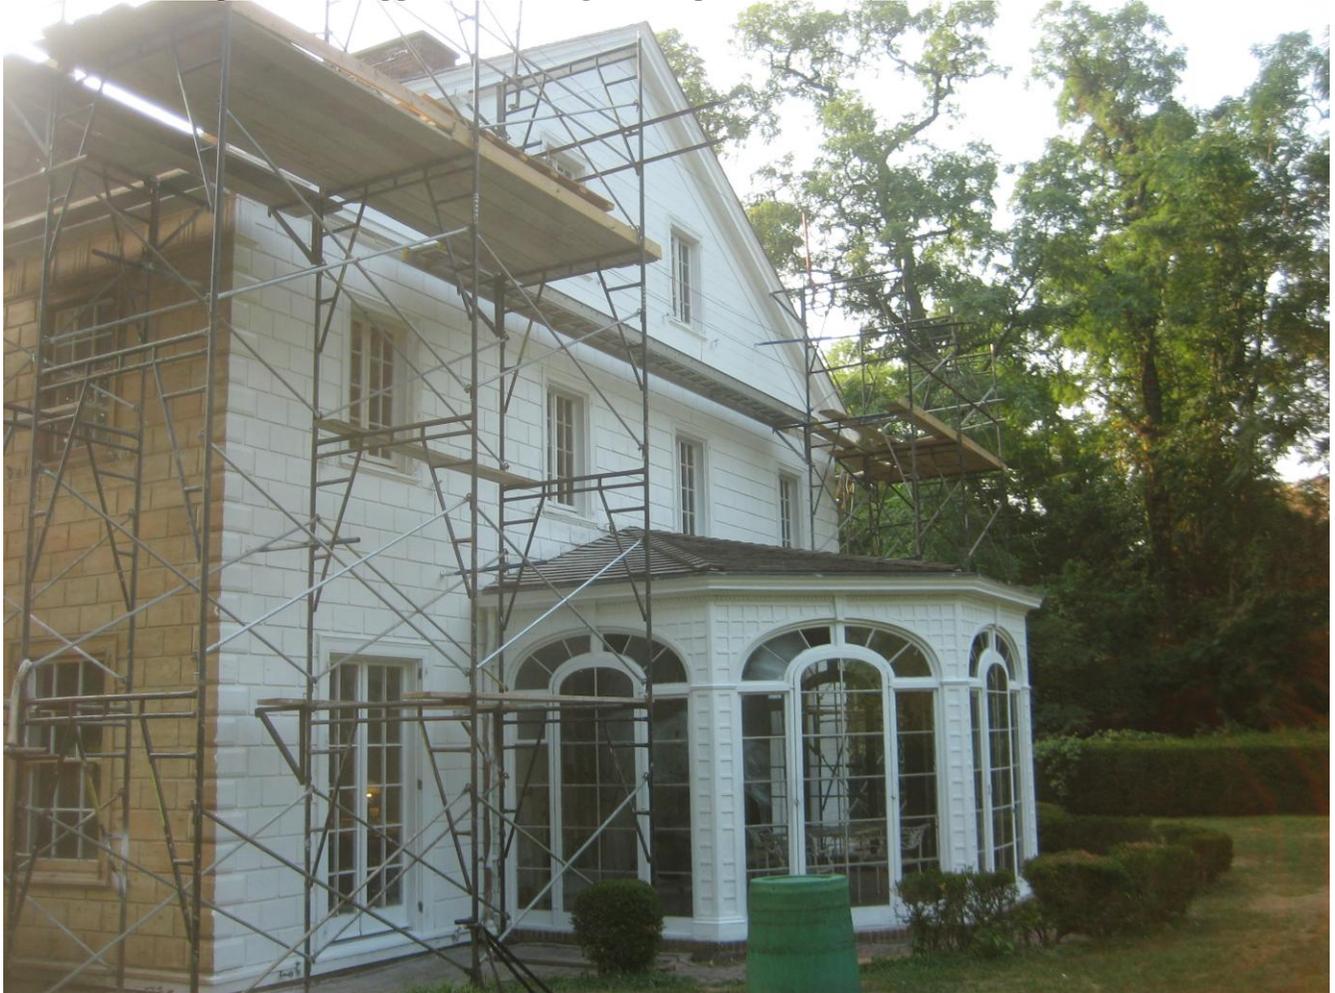
We were now in the position to begin repainting Nassau Hall. A Prime coat of Sherwin Williams A-100 oil base primer was applied by spray and then lightly sanded by hand. A-100 is a long oil primer designed to block tannin bleed through and seal back stains from coming through the topcoat. Once the entire building was primed and approved by the Nassau County Inspector a second coat of Sherwin Williams A-100 primer was applied according to the specification. **(Picture #10 Primer)**

This was completed and approved by the inspector. We then moved on to applying the finish coat of Sherwin Williams A-100 100% Acrylic Latex, Flat Finish Topcoat, which was also sprayed on the exterior of the Hall. With great hiding capabilities and color retention A-100 Flat is Sherwin Williams best quality exterior flat finish.
