Rockland County Sewer District No. 1 – Renovation of Two Digesters and Sludge Hopper

In September of 2010, Alpine Painting was hired by the general contractor Spectraserv as a subcontractor for the rehabilitation of the wastewater treatment plant in Rockland County Sewer District No. 1. The scope of work included blasting and coating the interior and exterior covers of two digesters. Both digesters have a 90' diameter and 20' tall concrete walls. The first digester had a fixed roof to be blasted and coated on site. Spectraserv was responsible for fabricating a replacement floating roof for the second digester. The second digester parts were blasted and primed at the manufacturers shop and the skirt plates were to be sent to Alpine's shop to be intermediate and finish coated prior to installation.

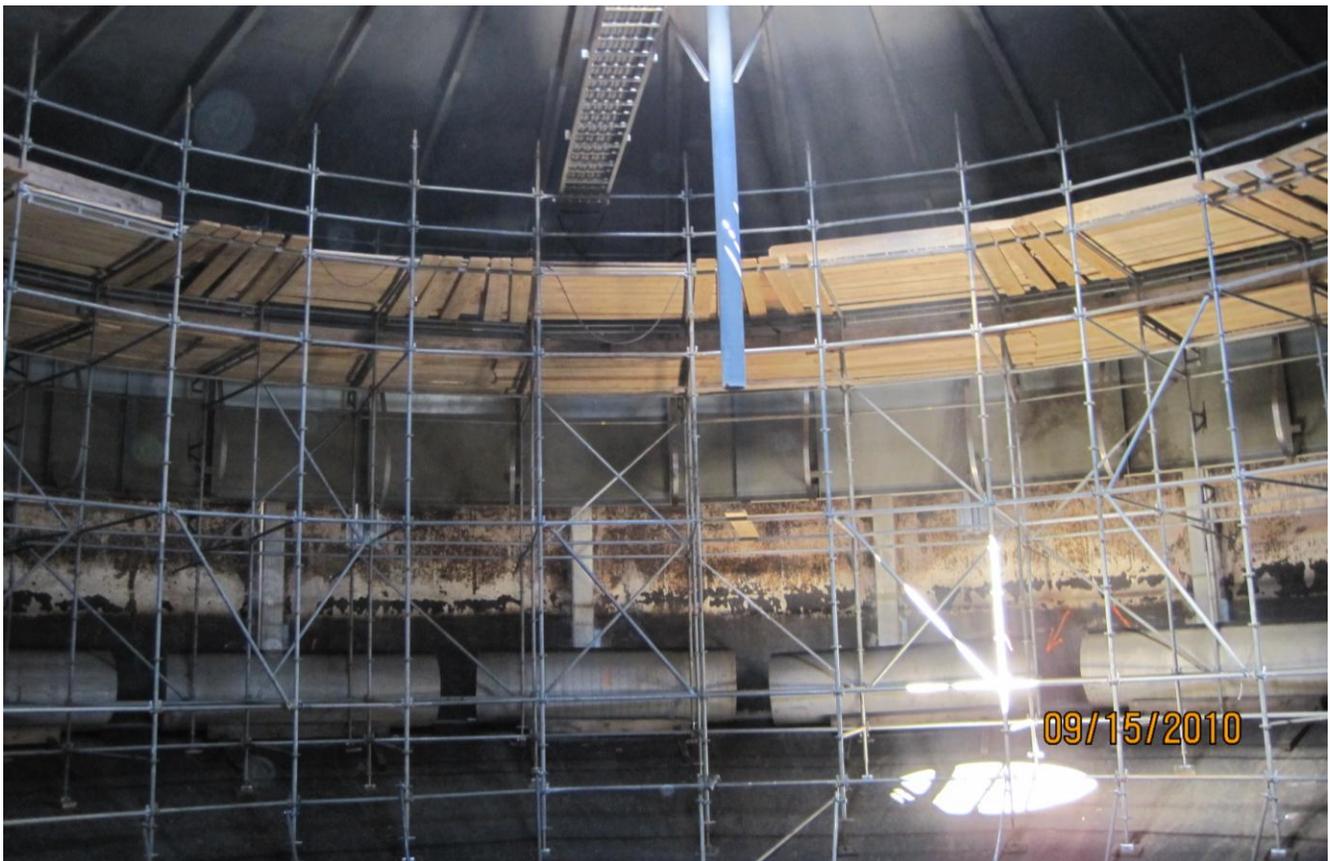
We installed a uniquely designed frame & suspended scaffold system inside the tank to access all surfaces. Upon completion of the interior we moved to the exterior of the digester. **(Picture #2 Interior Scaffolding)**

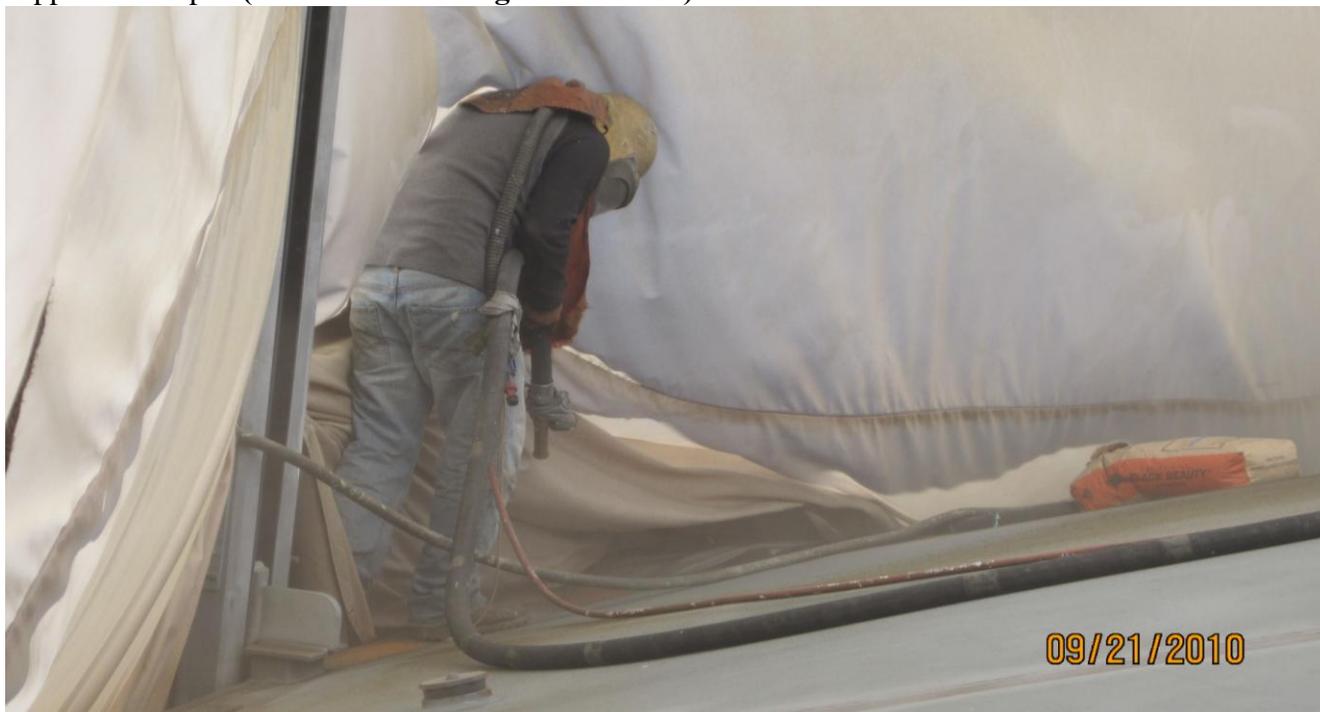
We contained the tank exterior by welding the scaffolding on to the external surface and used it to support the tarps. **(Picture #3 Blasting the Exterior)**

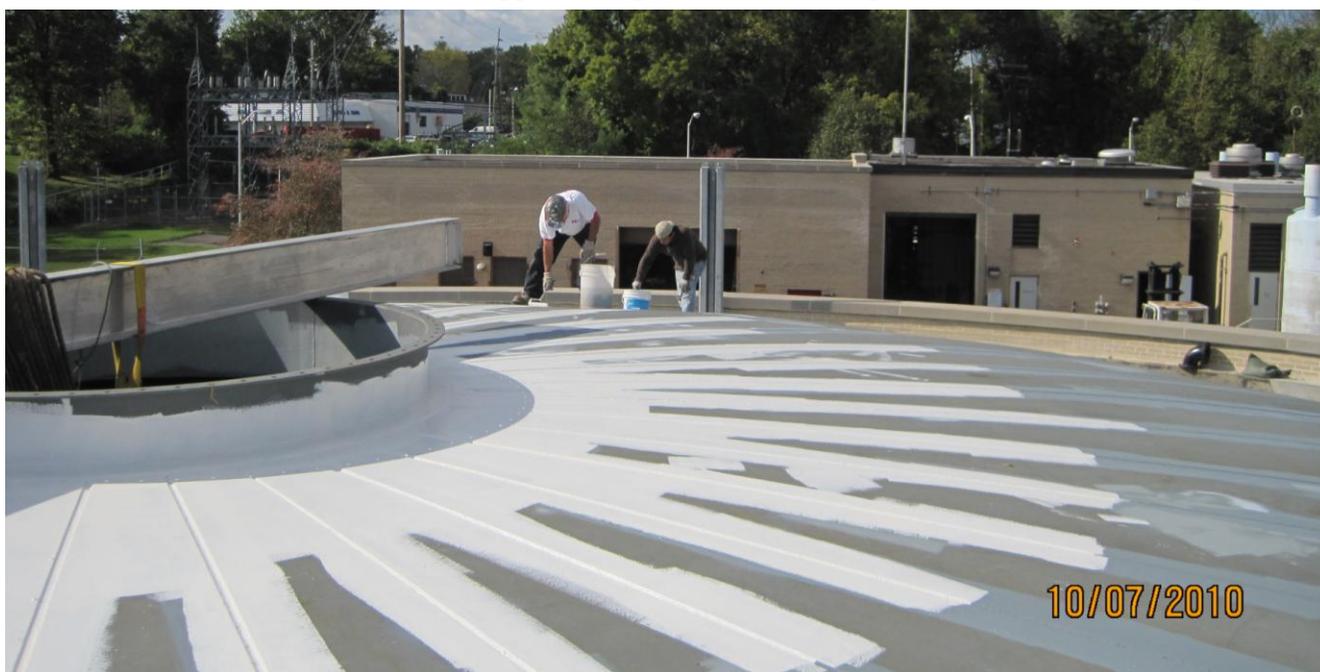
Once the surface was sandblasted we applied the primer and the stripe coat. **(Picture #4 Stripe Coat)**

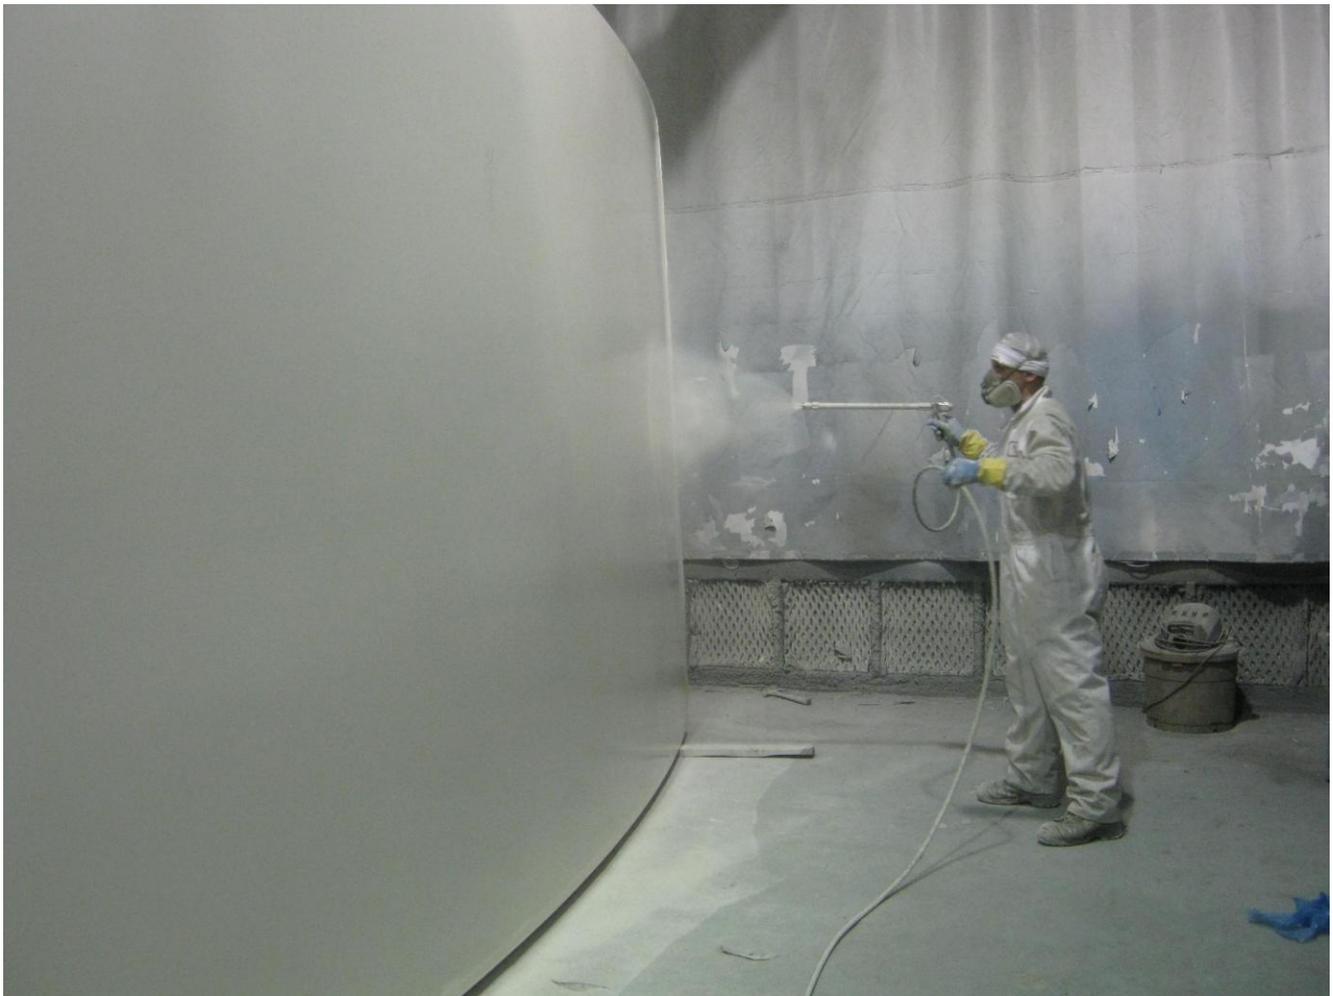
After the fixed digester cover was finished we began the shop work for the second digester. As soon as all of the shop work was complete, the separate pieces of the floating cover were shipped to the site to be installed on the digester. The welds and any other necessary areas would be spot blasted and then the coating would be applied. When the floating digester cover was installed our interior lining crew mobilized on site to perform the finish coat application to the interior ceiling. **(Picture #5 Shop Priming)**

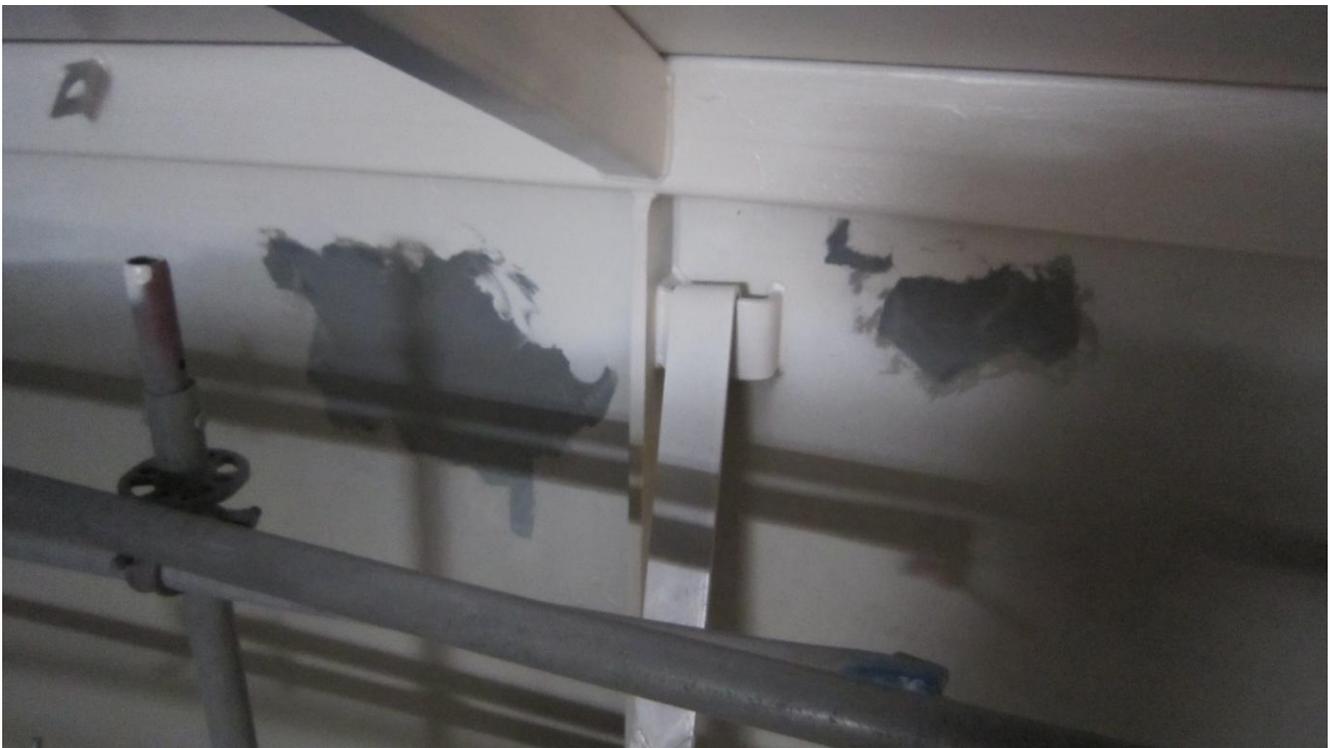
Upon inspection of the surface by our quality management team, we noticed an issue with the adhesion of the shop applied interior finish coat to the primer. After spot blasting the welded areas, it was evident that the finish coat did not adhere well to the primer. Based on our shop quality control reports it was not clearly evident that there were any mistakes during either of the shop applications. Upon further investigation, the stripe coat application of Macropoxy 646 exhibited a very good bond to the primer and also to the finish coat and appeared to be performing extremely well as a system. The same results exist on the exterior of the skirt plates where the Macropoxy was used. After an in-depth review of our quality control reports, we contacted Sherwin Williams to inform them of the situation and try to

determine whether we should continue with the application of the finish coat directly to the primer on the interior cover as specified. The decision was made by Alpine & Sherwin Williams to apply a full coat of Macropoxy 646 at 3 to 5 mils DFT to the interior cover as a tie coat between the primer and finish coat at no charge to Spectraserv or Rockland County. This decision was made to avoid possible project delays and a larger potential problem if the specified finish coat didn't adhere properly when directly applied to the zinc primer. **(Picture #6 Poor Paint Adhesion)**

Since the interior skirt plate finish coat had failed, we removed all loosely bonded material by brush blasting according to SSPC-SP7 (Brush Blast Clean). All surfaces of the interior cover were coated with the intermediate coat Macropoxy 646 at 4 to 6 mils DFT. The finish coat was then applied to the interior at the specified film thickness. Once the system cured we evaluated and found that the system performed as well as intended. This change in work added only a few days onto the overall schedule, and resulted in no additional charges to either Spectraserv or Rockland County. We were pleased that our quality assurance program caught this problem before it turned into a larger issue.
