<u>AMB Property Corporation</u> <u>Exterior Painting of 14 Warehouses at an Industrial Complex in New Brunswick, NJ</u>

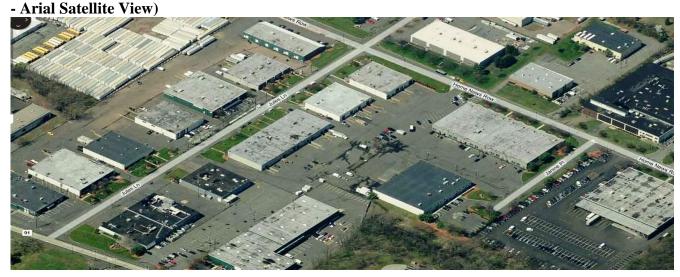
Alpine Painting was selected to bid the Exterior Caulking & Painting of 14 warehouse buildings ranging in size from the smallest at 12,000 sq. ft. and the largest of 42,220 sq. ft. of Floor Square Footage. (Map #1 - Site Map) Estimating the 14 buildings was a challenge because each building was different from the next in size, substrate and scope of work. Surfaces varied from Stucco, Brick, Split Faced Block, Aggregate Panels, Cinder Block, Poured Smooth Concrete Foundations, Metal Drip Caps, Gutters, Leaders, Corrugated Metal Roofing & Siding Metal Overhangs, Railings, Galvanized Guardrails, Overhead Doors, Prefinished Metal Window & Door Frames and more. (Satellite View #2

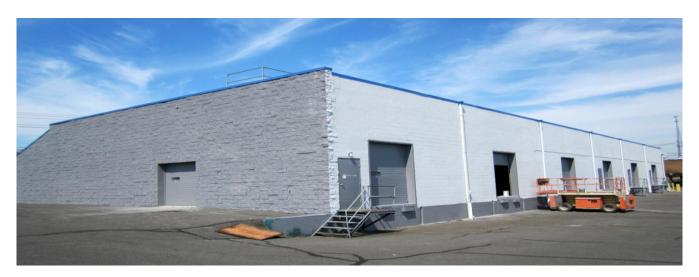
We discovered through conversations with the owner's representative, Amy Buchwald, that a specific color scheme was very important. We used a combination of three main colors and two secondary colors for each of the 14 buildings. During our pre-job walkthrough, my supervisor, project manager, Amy and I visited each building and compared the notes from our proposal with her color scheme to ensure that we were in sync. (**Picture #5 – Color Scheme**)

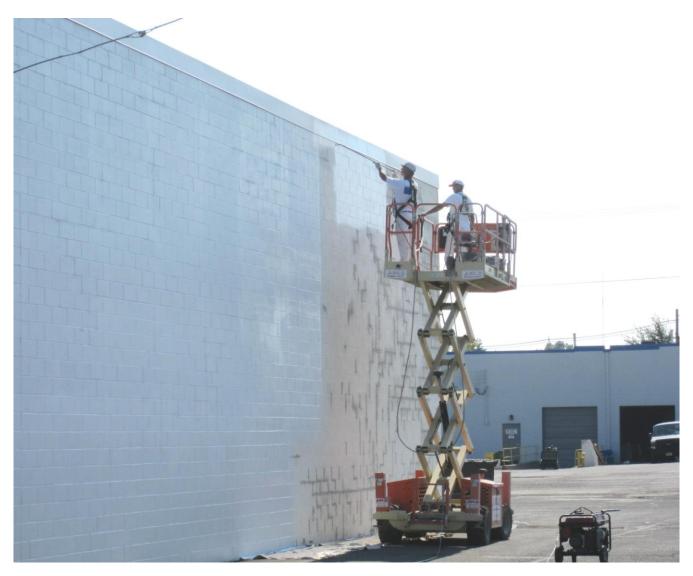
Two 30 ft. rough terrain scissor lifts were utilized to safely and more effectively access each building. Our men also used rolling scaffolding and various size ladders to work around the complex. Safety is a priority on every single one of our jobs. Our men used five point harnesses and lanyards while working on lifts. (**Picture #6 - Safety**)

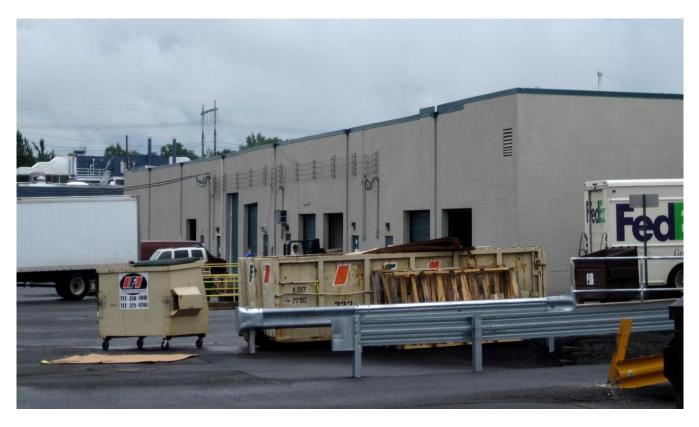
We also provided proper hazard communication and marked out and notified each building tenant of the work to be performed prior to working on their building. This was important because many building tenants needed to move vehicles, materials and equipment in order for us to safely get to all areas of the buildings. (Picture #7 Vehicles, Materials & Equipment)

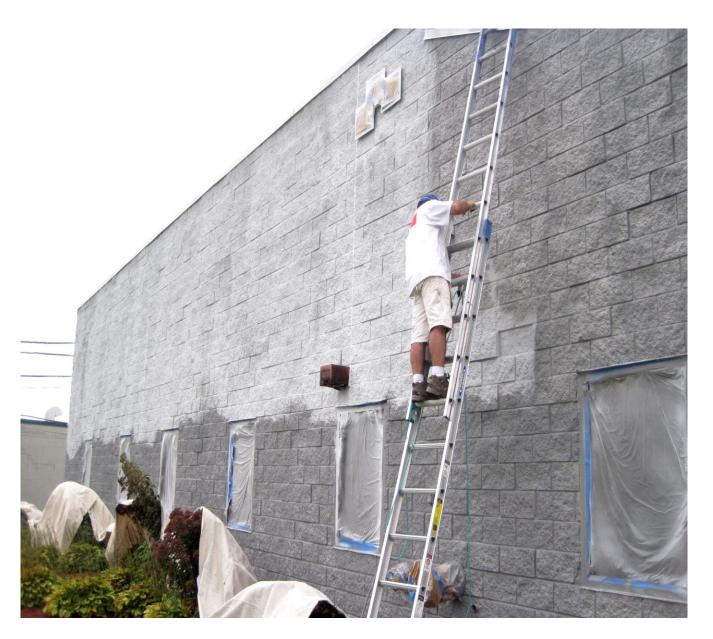
#8 - Spraying Elastomeric Finish Coat)

Any failing or deteriorated caulk was removed and replaced with Sikaflex 15LM Elastomeric Sealant. All peeling paint and rusted surfaces were hand tool cleaned. Once all of the rust and loose and peeling paint was removed our crew applied a full prime coat of Glidden Professional HydroSealer Primer/Sealer to the masonry surfaces on each building. Glidden's HydroSealer is a revolutionary product designed to bond to smooth concrete surfaces, bind chalking and worn surfaces and can be applied to new, dry masonry surfaces with a P.H. of 13 prior to a 30 day cure window. To provide a longer life span of the coating system we upgraded to an elastomeric finish coat. Glidden Professional's DecraFlex 300 Smooth Elastomeric Coating was chosen. DecraFlex 300 paint was a great choice because it is a premium quality, high build, elastomeric waterborne coating, that provides a long lasting weather resistant finish on exterior, above grade vertical masonry, stucco and poured concrete. It provides a waterproof film, even against wind-driven rain, yet breathes to allow entrapped moisture vapor to escape, preventing blistering. Superior elongation properties allow the film to expand and contract over existing hairline cracks without the reoccurrence of cracking through the film. (Picture

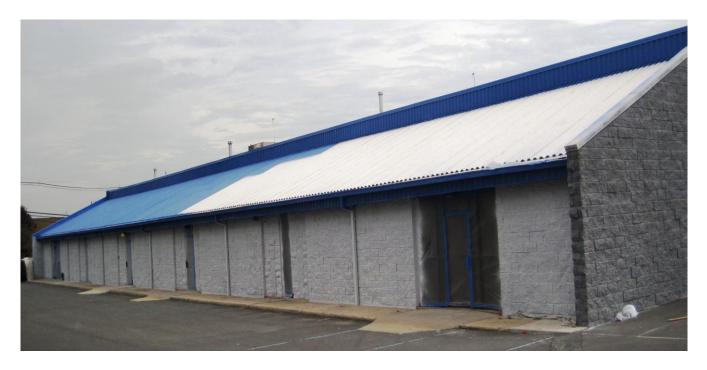
Prefinished metal surfaces were to be coated such as Drip Caps and Window & Door Frames containing a Baked-On Factory Coating. These surfaces were scuff sanded to provide a mechanical bond and promote paint adhesion. We then applied a specialized Bonding Primer, XIM- UMA, to ensure a chemical bond. Any rusted metal surfaces were primed with Devoe Devguard 4160, Rust Inhibitive Primer. Window Trim and other metal building surfaces were coated with Devoe Devflex 4216 High Performance Waterborne Acrylic Coating, Semi-Gloss Finish. Devflex 4216 has qualities such as alkyd-like hardness and durability, exceptional adhesion, superior flow and leveling, excellent gloss and color retention, low odor, and high hiding abilities. (**Picture #9 - Primer-Finish Coat**)

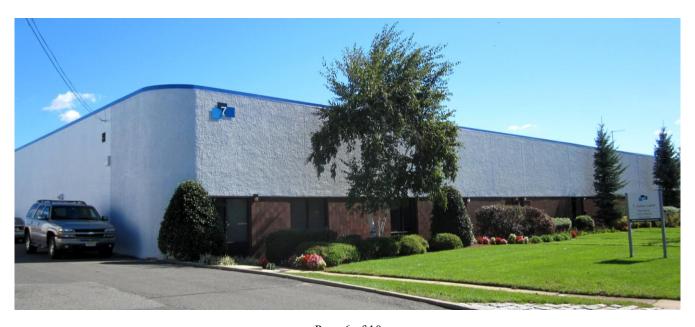
Since this project had a tight time frame Alpine utilized three crews of 3-4 men to work starting the middle of August through the entire month of September. September proved to be a very hot month in Central New Jersey. Our men had to use caution and not paint metal surfaces in the heat of the day or bypass certain areas of the building and paint them on cloudy days. We worked weekends to maximize the amount of work completed and to minimize the inconvenience to local businesses. Paint was applied by a combination of brush, roll and airless spray depending on the substrate and weather conditions. (**Picture #10 – Completed Building**)
