George Campbell Award: Rockland County Pipelines

William Johnson Award: Lucy the Elephant

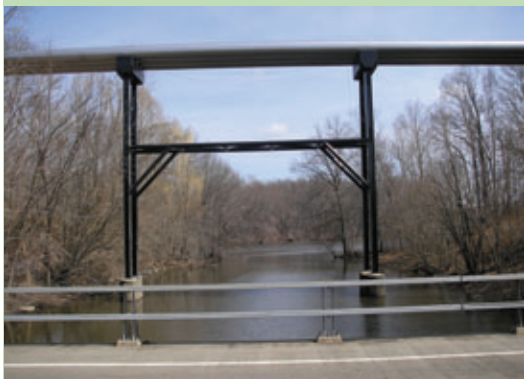
The Hackensack River Siphon, in Blauvelt, NY, also feeds into the reservoir managed by United Water Company. At 30 inches in diameter, the three pipes run 285 feet long and are 60 feet above the river. Trees and bushes grew out of the insulation, and raccoons had nested in one of the support columns.

Top: Hackensack River Siphon
Bottom: Naurashaun Brook Siphon
Photos courtesy of Alpine Painting and Sandblasting Contractors

The scaffolders constructed scaffolding approximately 300 feet long, 20 feet wide, and 60–80 feet over the Hackensack River. The site was fully contained, and water booms were installed. A slight setback came when local youths threw some of the scaffolding into the river.

The insulation sub-contractor removed the old aluminum jacket and insulation, and the contractor abrasive blasted the pipes to an SSPC-SP 6 finish, then primed them to prevent rusting. The work was conducted in the winter, with a one-million BTU heater to maintain climate control. When the river began to freeze, ice eaters were deployed below the scaffolding. Pipes were reinsulated the same way as the Naurashaun location.

In order to blast and coat the steel support structure, it had to be fully contained. This concerned the scaffold PE because the location was subject to strong winds. The solution was to remove the containment above as the workers moved down the support structure. The project was completed 100 days fewer than required by contract.

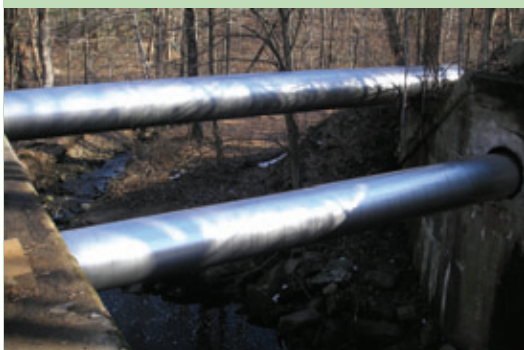
The two pipes at the Naurashaun Brook Siphon location are 36 inches in diameter and span a feeder brook to the United Water reservoir in Blauvelt, NY. One pipe, 55 feet long, was previously coated with an asbestos coating. The other, 29 feet long, was previously covered with insulation and an aluminum jacket, most of which had fallen off. Plant life was growing out of the remaining insulation.

Work at the Naurashaun site took eight weeks to complete due to weather delays. Before the painting crew could start work, they had to install water booms

to protect the brook. A scaffold subcontractor tied the scaffolding into the concrete abutment walls supporting the pipes and the shorelines on both sides of the brook. The scaffolding also provided full containment.

A subcontractor removed asbestos. Both pipes were abrasive blasted to SSPC-SP 6, Commercial Blast Cleaning,

and the steel strapping that held the pipe to its supports had to be manually removed, power tool cleaned, and painted one strap at a time to eliminate any danger of shifting the pipes.

It was determined the pipes had to be treated as immersion service, and the paint system of both locations was changed to one that could withstand potential immersion and the atmospheric conditions of coating in colder weather. The entire pipe lengths were

coated with full prime, intermediate, and finish coats before the insulation sub-contractor reinsulated the pipes and installed a new stainless steel jacket.

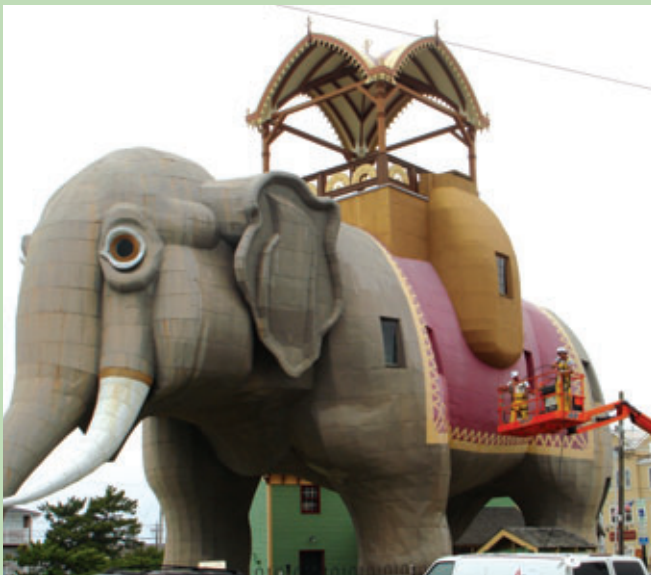
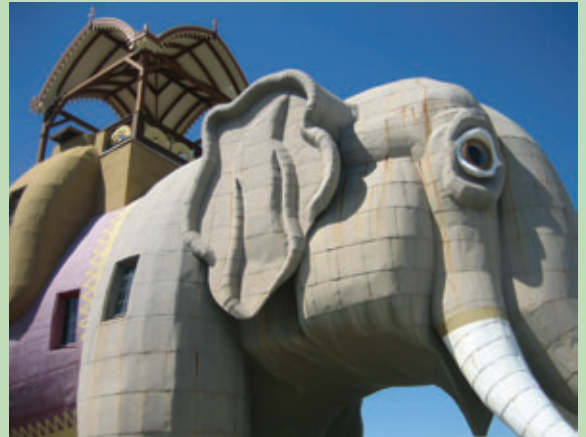
Photos courtesy of Richard Helfant, executive director of Lucy the Elephant

The contractor prepared the area by covering the surrounding surfaces where work wouldn't be performed and placing plastic and tarps underneath the working area to contain paint chips. The areas to be painted were pressure washed using 600 psi or less to remove dirt, dust, and loose and peeling paint. Some surfaces were prepared to SSPC-SP 2, Hand Tool Cleaning, to remove loose rust and peeling paint.

Deteriorated and rotten wood mullions and wood frames were repaired with a flexible epoxy. Existing brittle and deteriorated glaze was removed from the window panes, and a window

glazing compound was applied around the perimeter of each individual window pane.

To avoid overspray, paint was applied by brush and roller. A spot prime coat was applied where necessary, followed by a rust-inhibitive epoxy primer to rusted metal surfaces. All of the gray surfaces of Lucy received two full finish coats of a 100% acrylic, rust preventative, high-performance, satin finish, elastomeric coating. The red, yellow, and brown colors on the carpet, saddle, eyes, trunk, and toes were coated in an acrylic latex, satin finish topcoat.
